Inspection Report Minerals Regulatory Program

Mine Name: Lisbon Valley Project

Permit number: M/037/088

Inspection Date: December 13, 2004

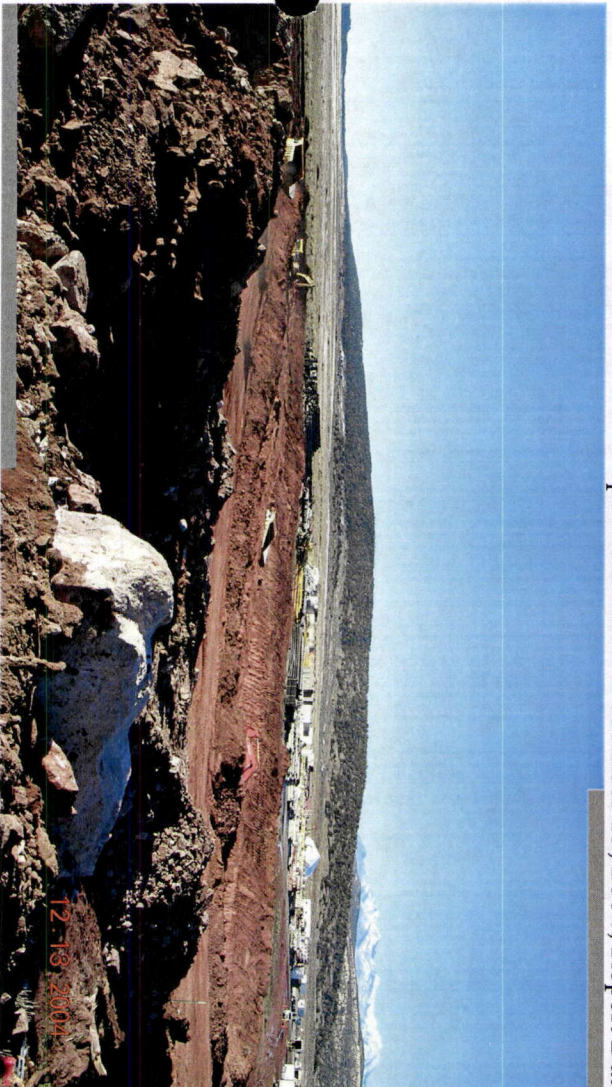
During the inspection, the operator was putting in reinforcing steel for the primary crusher (Photo 2) and was excavating a trench for the reclaim tunnel (Photo 1). Near the Lisbon Valley Road, an area was being graded for a parking lot. I saw no concerns with any of this activity.

Photo 1. The two partly-visible trackhoes are in the trench being dug for the reclaim tunnel. Beyond the reclaim tunnel on the right is the crusher laydown area.

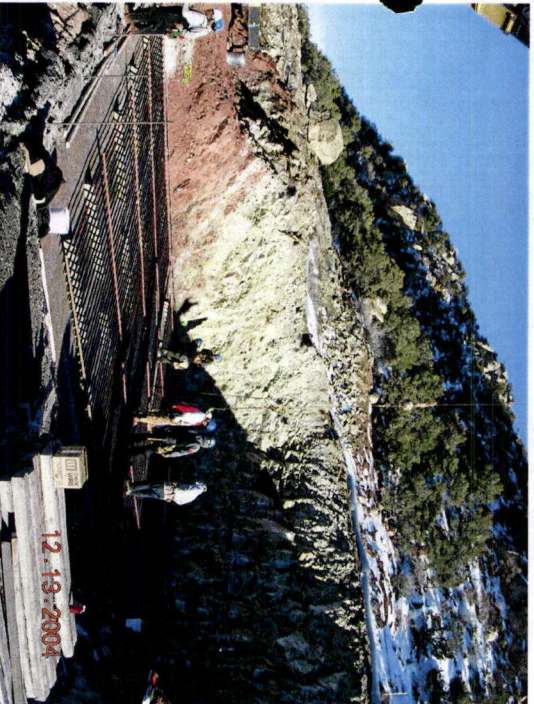
Photo 2. Reinforcing steel for the primary crusher foundation.
